A case study: delayed failure of a deep cutting in lodgement till

Recent research on the delayed failure of cuttings in clay clearly recognises and predicts progressive delayed failure of deep cuttings. This is due to a combination of strain-softening, weathering, dissipation of negative excess pore water pressure generated at the time of excavation, and frequent occurrence of prolonged periods of wet weather. There have been several slope failures of this kind in Northern Ireland. This paper discusses a case study based on a failure of a deep cutting, excavated at a slope of 1 in 2, on the A1 near Dromore (County Down) in Northern Ireland. The cutting was in lodgement till, a stiff, heavily overconsolidated clay. The failure occurred approximately 30 years after the cutting was excavated, following a prolonged period of heavy rainfall. An analysis of the failure, together with laboratory test data on soil samples taken from the site, confirmed that by using long-term soil strength parameters the factor of safety of this slope was unity. The conclusion of the analysis is that slopes excavated in this soil should be designed (and assessed) on long-term strength parameters.

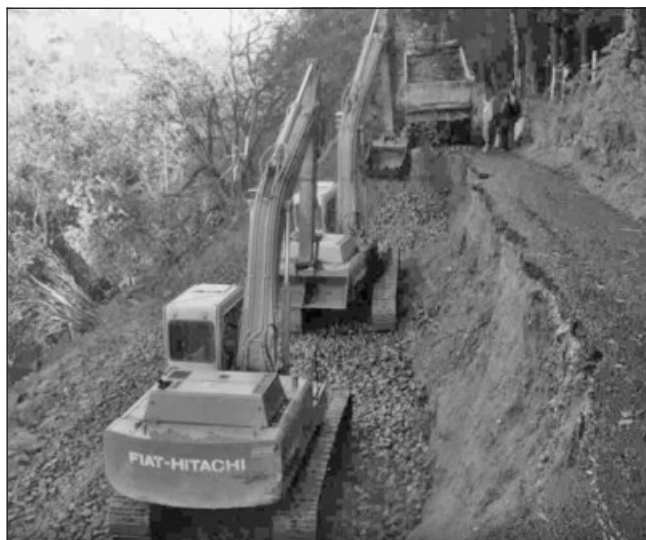
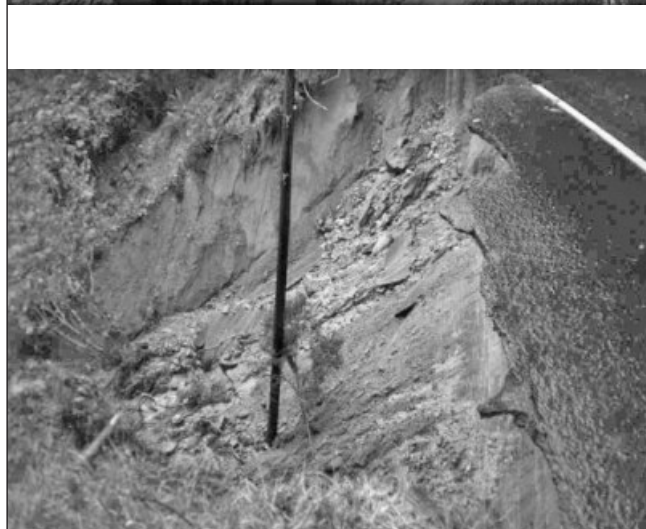
- (a) *Glenshesk landslide in 1998*: located on the east coast of County Antrim. The landslide occurred on Monday 2 November 1998, when a 30 m length of Greenans Road at Glenshesk, near Ballycastle, fell into the adjacent glen, leaving a narrow strip of road still crumbling alongside a sheer drop about 15 m deep (Fig. 1). The welfare of 15 families cut off by the landslide was of prime concern, so immediate action was taken to close the road and cordon off the landslide area, and an emergency plan was put into operation. The drainage channel had gradually become blocked over many years, and the water from the upper slope eventually ended up discharging entirely through the sand and gravel deposits beneath the roadway. Five days after the landslide, the filling operation was completed: over 13 000 t of rock armour was removed from the nearby riverbed and placed at road level, allowing the road to be reopened to traffic. Drainage and culvert replacement

Fig. 1. Glenshesk slip

works were completed during the following days, and the road was resurfaced.

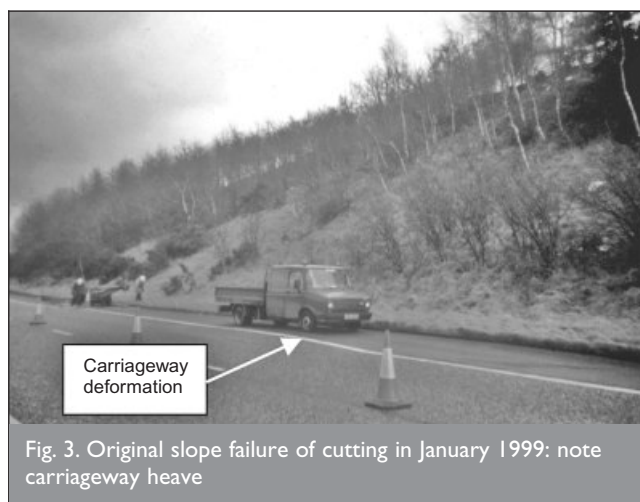
The cutting is located near Dromore on the A1 (Fig. 2). It was excavated to a slope of 1 to 2 (27°) in 1972, and is approximately 19 m high. It is not clear whether or not a detailed slope stability analysis had been carried out at the time of the excavation. It is likely that the original excavated slope was based on the simple 1V:2H rule of thumb widely used for cuttings in stiff clays at that time. The cutting first failed in January 1999 as a result of a large rotational slide developing (Fig. 3). A plan showing the extent of the failure is shown in Fig. 4. The failure occurred after several months of significantly higher-than-average monthly rainfall levels, and at the end of several days of exceptionally heavy rainfall: 41 mm of rain fell on 30 December 1998.

Fig. 3. Original slope failure of cutting in January 1999: note carriageway heave

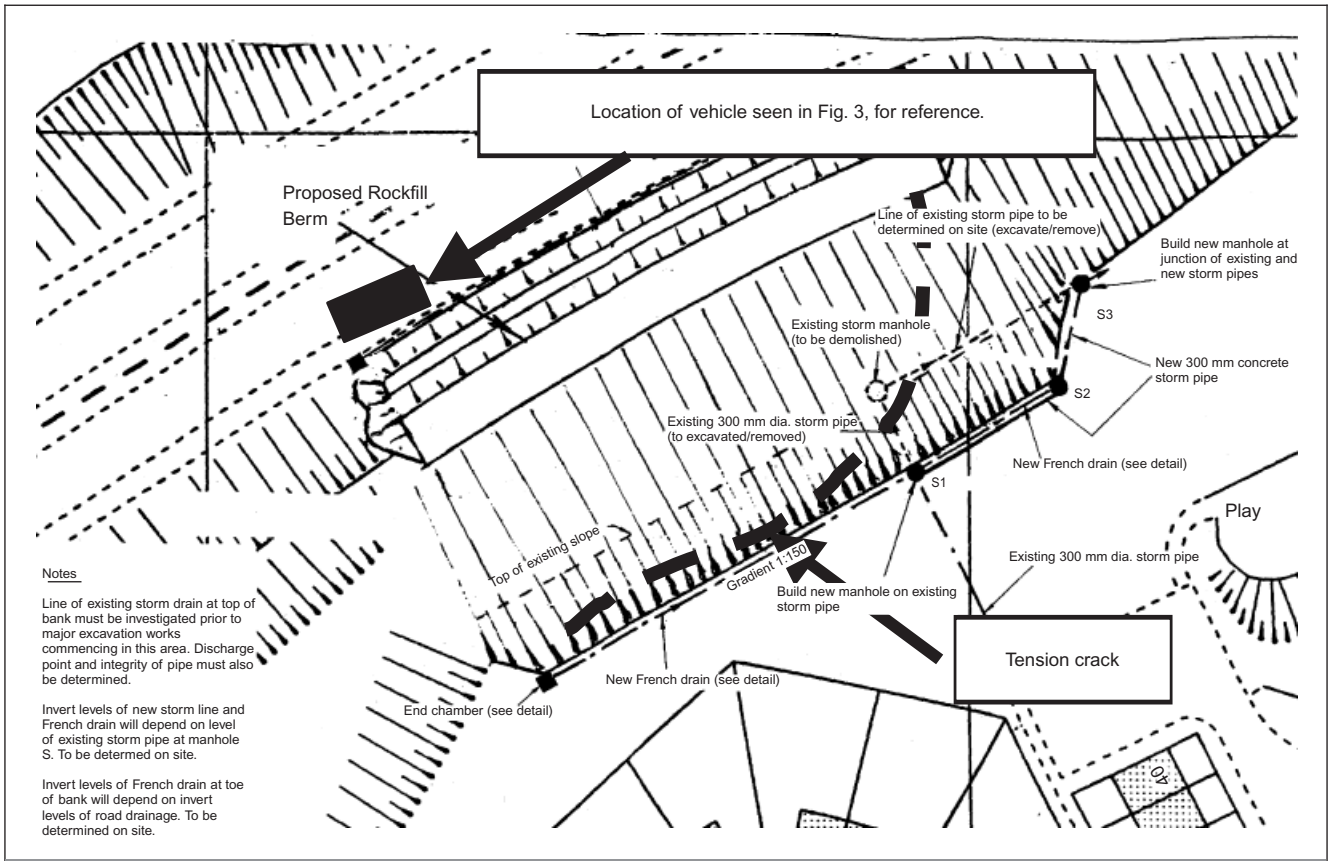
Fig. 4. Plan drawing of temporary repair and location of tension crack (scale 1:20 000)

A temporary remedial design was proposed by Construction Service: it consisted in regrading the cutting to a slope of 1V to 2.4H (23°) and providing a counterweight berm strategically positioned at the toe. This was carried out as an interim measure to prevent further disruption to traffic flows and

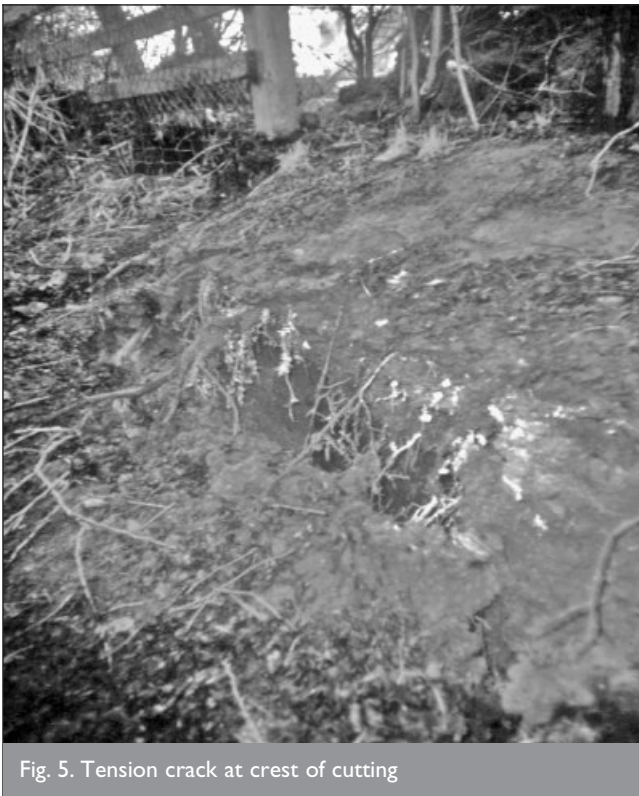
A large tension crack was visible close to the crest of the cutting (Fig. 5), and the toe of the landslide revealed itself as a distinct bulge, emerging in the inside lane of the dual carriageway (Fig. 6). The hard shoulder was raised approximately 0.5 m and, as a result, the inside lane of the dual carriageway adjacent to the landslide had to be closed immediately. The estimated position of the slip surface can be seen in Fig. 7(a). This estimated slip surface is based largely on the geometry of the tension crack and the distortion of the carriageway, but was confirmed by stability analysis.

Fig. 5. Tension crack at crest of cutting

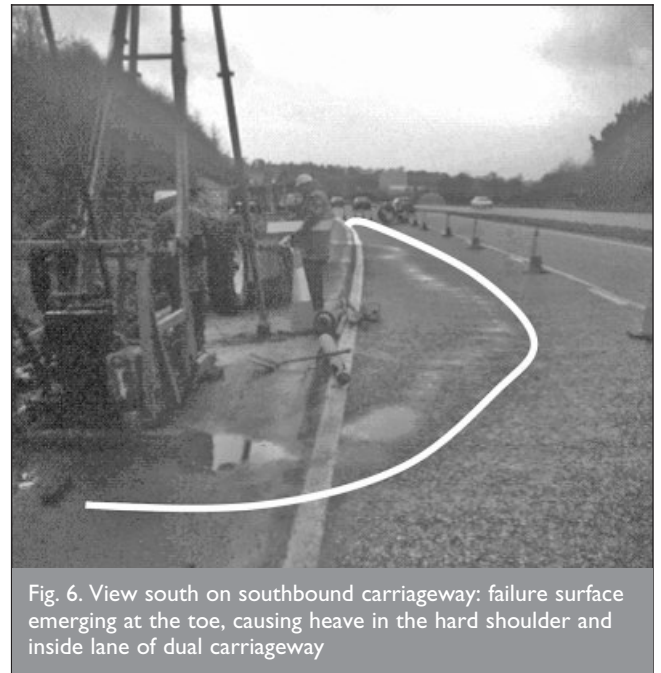
Fig. 6. View south on southbound carriageway: failure surface emerging at the toe, causing heave in the hard shoulder and inside lane of dual carriageway

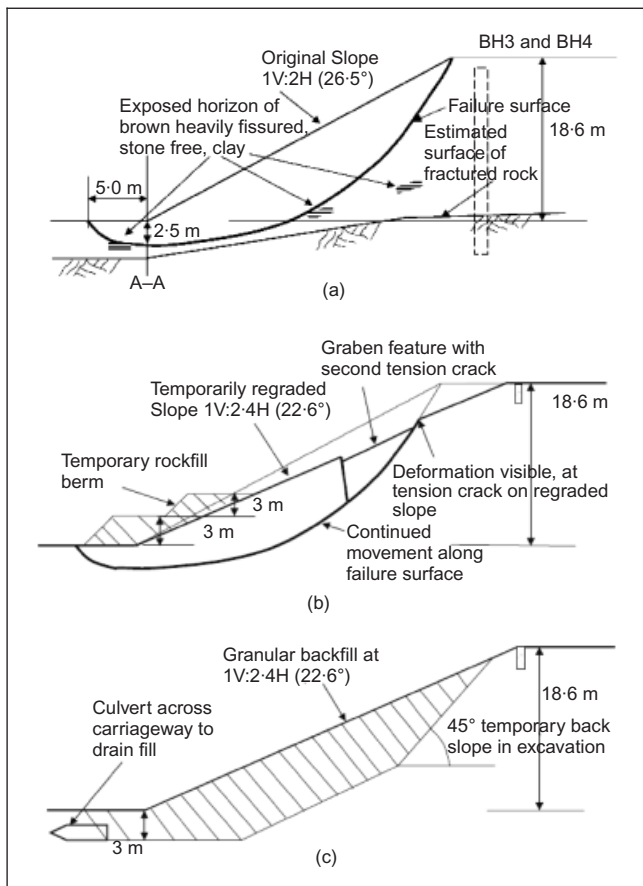
Fig. 7. Sequence of events of failure, temporary and permanent repair: (a) estimated shape of failure surface (January 1999); (b) regraded slope with temporary berm and Graben after further movement (October 2000 to March 2001); (c) final repair—excavation and granular fill (December 2001)

minimise further distress to the carriageway. These temporary remedial works were completed in August 1999, and the cross-section of the regraded slope is shown in Fig. 7(b). However, owing to various constraints, such as horizontal sightline requirements for the carriageway and land ownership problems, the work undertaken did not fully reflect the original design recommendations. The berm was undersized because it had to be 'trimmed' down significantly to satisfy safety regulations, that is, driver visibility criteria. Furthermore, the

slope was not regraded fully to the specified design gradient because permission could not be secured from the local authority to remove part of a recreational area/playing pitch at the crest of the cutting. Emergency drainage systems were also implemented at the crest and toe of the slope by excavating trenches up to 1.5 m deep and filling with coarse aggregates.

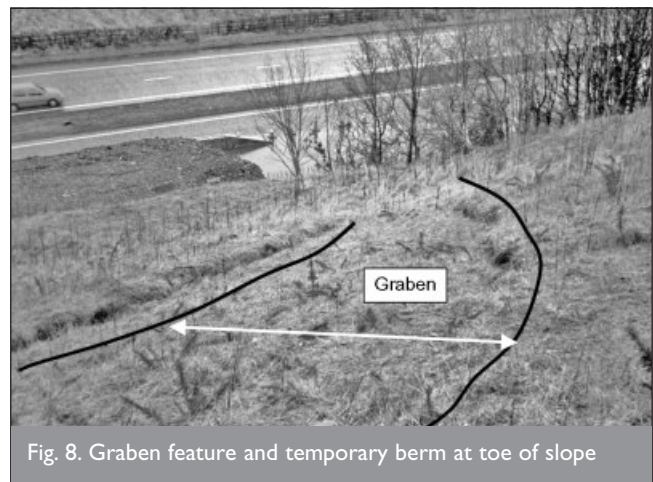
Subsequent movement of the temporarily repaired slope was recorded in October 2000, following a further period of heavy rainfall. Finally, on 6 November 2000, following another period of exceptionally heavy and prolonged rainfall—approximately 40 mm in 24 h—the slope moved significantly, and a Graben feature formed (see schematic in Fig. 7(b) and photograph in Fig. 8). One lane of the dual carriageway was again closed to traffic. A further large temporary berm, extending well into the existing carriageway, was placed at the toe of the slope to increase the stability and prevent catastrophic failure. This is visible in Fig. 8.

Fig. 8. Graben feature and temporary berm at toe of slope

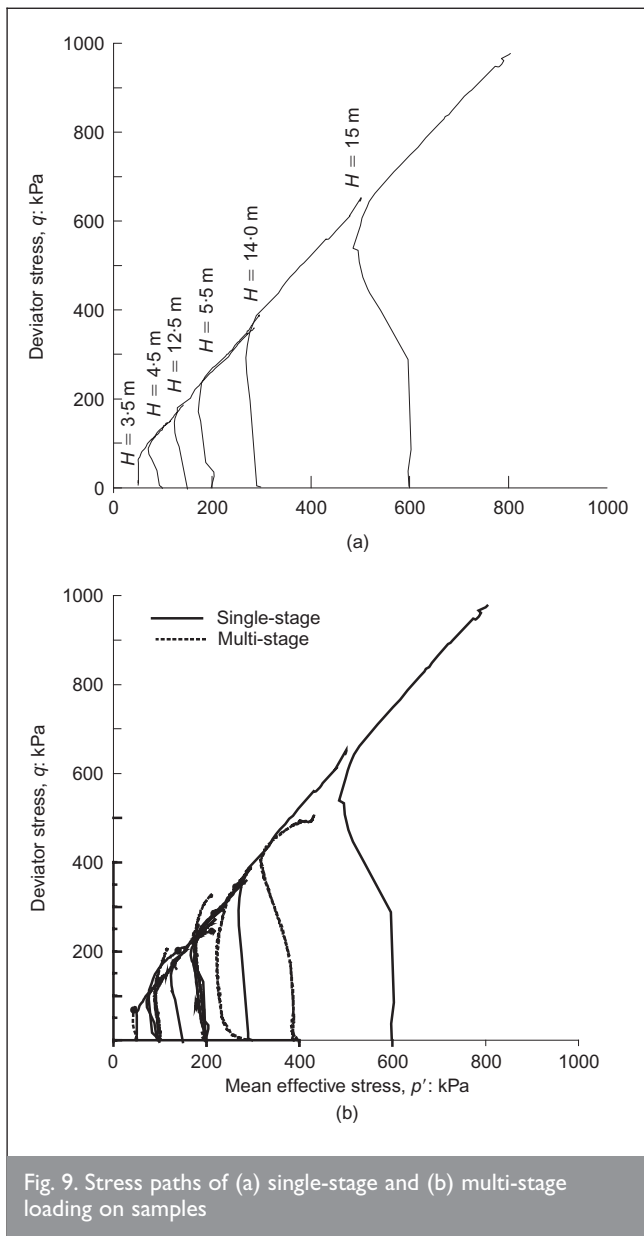
Figure 9(a) shows the deviator stress plotted against mean effective stress for single-stage tests performed on six samples obtained from borehole 3. These tests were performed by Soil Mechanics Ltd, and the test data were analysed to estimate the strength parameters at failure (peak) and critical state. The failure state was identified by locating the points on the stress paths in the $q:p'$ plane where the stress ratio, σ'_1/σ'_3 , reaches a maximum value, and they are shown in Fig. 10(a) (the solid points represent the data obtained from single-stage tests). As stated previously, none of the samples reached critical state, even at large axial strains. Accordingly, the stress states of the samples at the end of the tests were considered a reasonable representation of the conditions prevailing at the critical state, as shown in Fig. 10(b).

Fig. 9. Stress paths of (a) single-stage and (b) multi-stage loading on samples

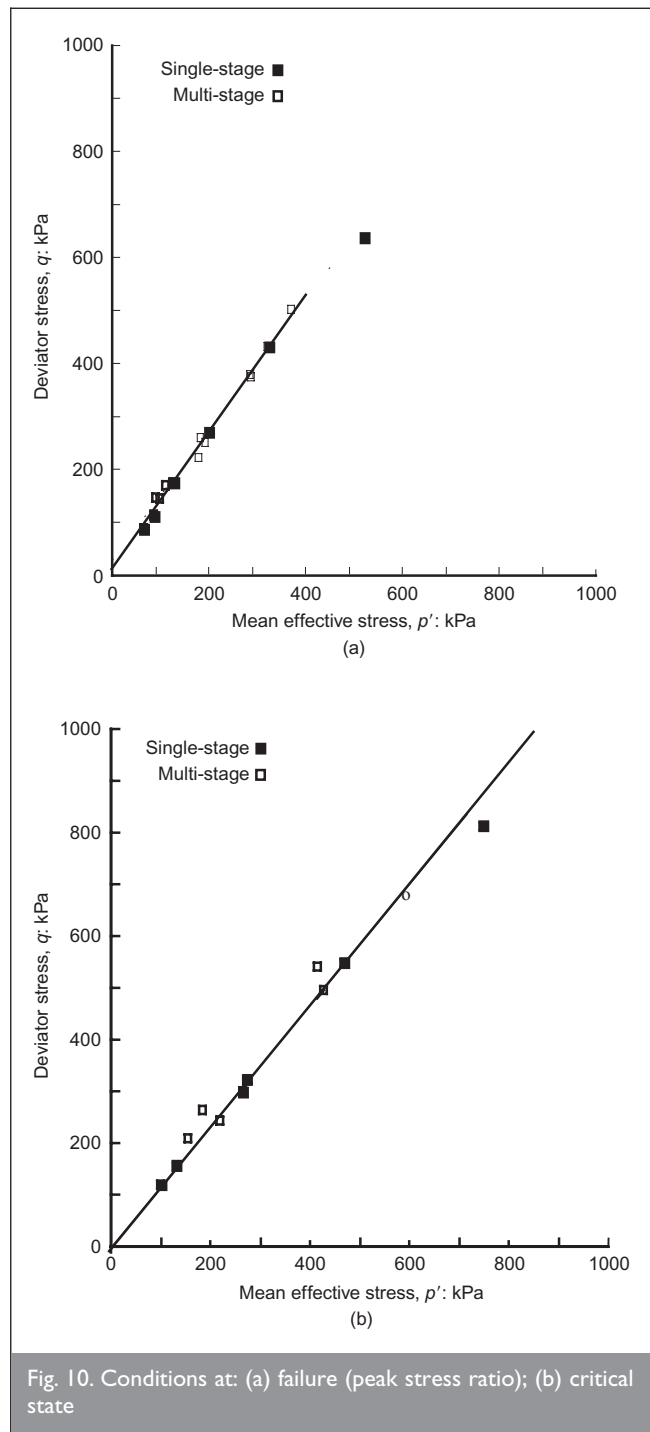
Fig. 10. Conditions at: (a) failure (peak stress ratio); (b) critical state

detrimental effect on the strength properties of the soil. Fig. 9(b) shows the stress paths obtained for stage tests performed on samples obtained from borehole 3; also included are the stress paths obtained from single-stage tests. It appears that the position of the failure line is not particularly affected by the stage loading, as it yielded results similar to those of single-stage loading. For the estimation of the strength parameters, data obtained from single-stage and multi-stage loading were considered. The slope of the failure line, H (Fig. 10(a)), is approximately 1.29, and the intercept c_{qp} is approximately 13 kPa. These values correspond to an angle of internal friction of 32° and cohesion c' of approximately 4 kPa. However, the effective cohesion of tills, particularly those found in Ireland, are very low, and in some cases insignificant.¹⁰ The slope of the critical state line Fig. 10(b), M , is approximately 1.18, and this corresponds to an angle of

internal friction of 30° . There appears to be no significant difference between the angle of internal friction at peak and that at critical state, though for the purpose of analysis an angle of internal friction ϕ' of 31° and a cohesion c' of 1 kPa were adopted. This small amount of cohesion was included to allow for progressive failure, and such failures are particularly prevalent in glacial till, where the clay is the predominant material. Also note that the cohesion c' of 1 kPa is somewhat lower than the measured value. However, soil along the failure surface was not exposed to uniform straining, and therefore an assumption was made to analyse the slope at conditions close to critical state.

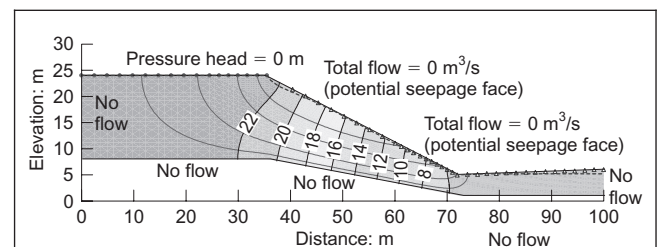
Figure 11 illustrates the steady-state seepage conditions, based on the assumptions of infiltration at ground surface at the top of the slope, runoff on the actual slope, and an impermeable bedrock basal boundary. The groundwater flow is approximately parallel to the slope, with corresponding pore pressure ratios (ru) in the region of 0.4 to 0.5. Clearly, these are stringent drainage conditions, which to a large extent reflect the impervious rock surface at shallow depth at the toe of the slope. Based on the shear strength parameters of $c' = 1$ kPa and $\phi' = 31^\circ$, the calculated minimum factor of safety is 0.99, corresponding to the circular slip surface or failure plane shown in Fig. 12. This

Fig. 11. Seepage condition: original slope

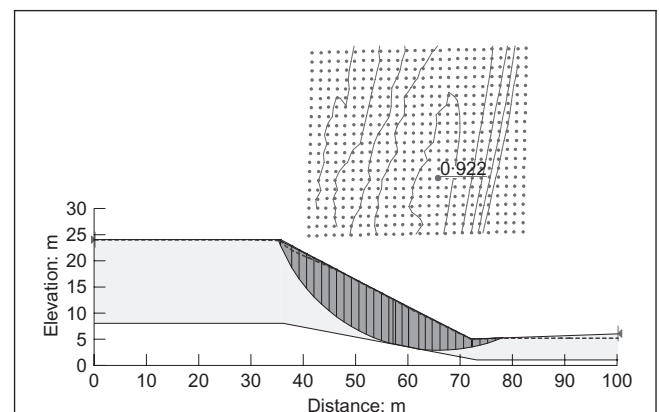
Fig. 12. Slope stability analysis, original slope: $c' = 1$ kPa, $\phi' = 31^\circ$

critical slip surface emerges near the top and bottom of the slope, and is therefore in general agreement with the actual failure surface. The fact that the minimum factor of safety is very close to unity is, to some extent, fortuitous, because the inclusion of a tension crack and/or the use of a different method of analysis would have resulted in an even lower factor of safety. Nevertheless, these computations confirm that the strength parameters obtained from laboratory testing, combined with the assumed groundwater regime, provide a clear and consistent picture of the mechanism of the original failure.

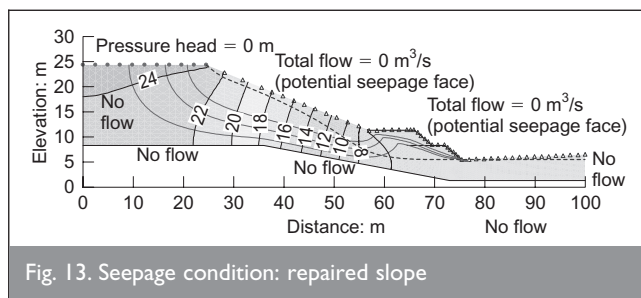
The groundwater regime incorporating the 'as constructed' remedial measures and making use of the same assumptions, as discussed above, is shown in Fig. 13. Comparing this with Fig. 11, it can be seen that the remedial measures had little effect insofar as drainage is concerned, with the values of pore water ratio remaining in the range 0.4 to 0.5.

Fig. 13. Seepage condition: repaired slope

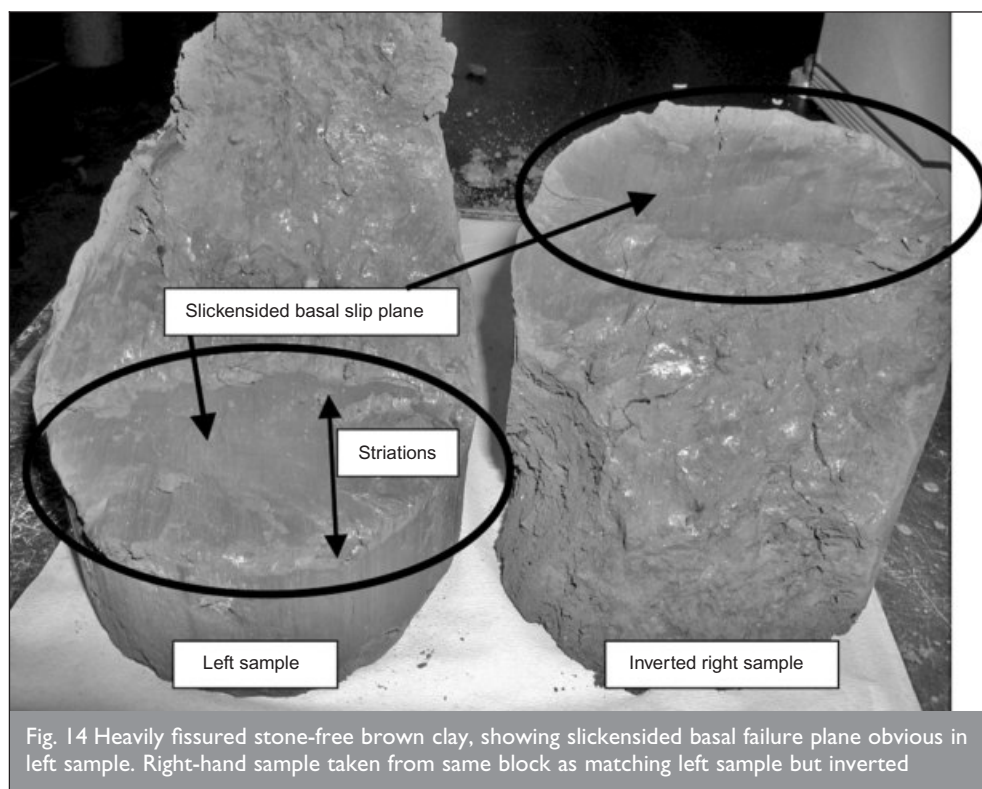
large triaxial sample taken across the basal slip plane in the heavily fissured clay. The slickensided surface of the slip plane can be clearly seen in the left sample, along with striations showing the direction of relative movement. The right sample is the inverted match of the left sample, and the slickensided slip plane can be seen at the top of this sample.

Fig. 14 Heavily fissured stone-free brown clay, showing slickensided basal failure plane obvious in left sample. Right-hand sample taken from same block as matching left sample but inverted

A layer of heavily fissured stone-free brown clay found to be coincident with the basal slip plane may also have contributed to the instability of this slope. Although some evidence of this layer was found in a preliminary site investigation, the layer was largely ignored in the original analysis. It is likely that this clay-rich layer reduced the overall mobilised shear strength along the failure plane and contributed to the failure.

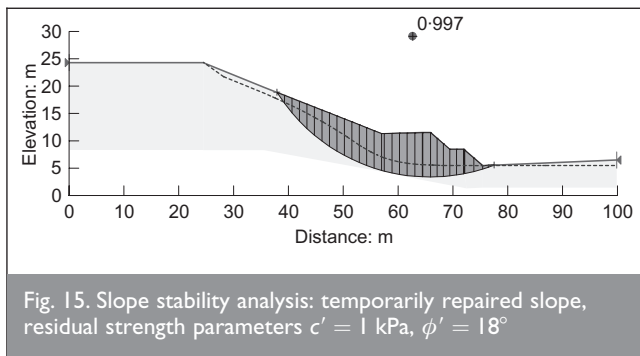
Extensive residual shear strength tests using a ring shear apparatus were subsequently carried out on this heavily fissured clay,¹³ and gave a residual shear strength of $\phi' = 18^\circ$, with plastic and liquid limits of 32% and 60% respectively. A stability analysis based on this residual shear strength gave an estimated factor of safety of this slope of approximately 1.0, as shown in Fig. 15.

Following costing of various remediation solutions, including soil nailing, a reticulated pile wall and deep drainage, the decision was made, based on cost and risk, to repair the slope by excavating the material to below the failure surface and replace it with free-draining crushed rock.
