A case study: delayed failure of a deep cutting in lodgement till

Recent research on the delayed failure of cuttings in clay clearly recognises and predicts progressive delayed failure of deep cuttings. This is due to a combination of strain-softening, weathering, dissipation of negative excess pore water pressure generated at the time of excavation, and frequent occurrence of prolonged periods of wet weather. There have been several slope failures of this kind in Northern Ireland. This paper discusses a case study based on a failure of a deep cutting, excavated at a slope of 1 in 2, on the A1 near Dromore (County Down) in Northern Ireland. The cutting was in lodgement till, a stiff, heavily overconsolidated clay. The failure occurred approximately 30 years after the cutting was excavated, following a prolonged period of heavy rainfall. An analysis of the failure, together with laboratory test data on soil samples taken from the site, confirmed that by using long-term soil strength parameters the factor of safety of this slope was unity. The conclusion of the analysis is that slopes excavated in this soil should be designed (and assessed) on long-term strength parameters.

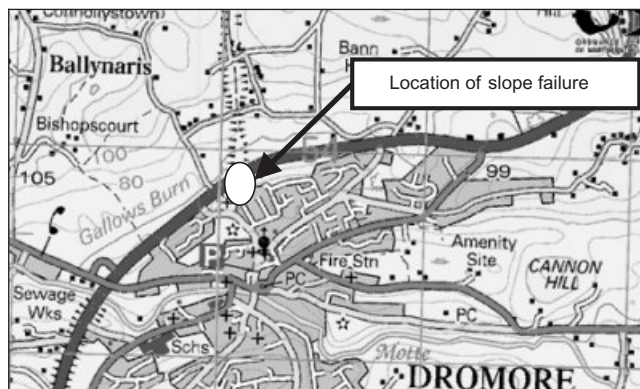
The cutting is located near Dromore on the A1 (Fig. 2). It was excavated to a slope of 1 to 2 (27°) in 1972, and is approximately 19 m high. It is not clear whether or not a detailed slope stability analysis had been carried out at the time of the excavation. It is likely that the original excavated slope was based on the simple 1V:2H rule of thumb widely used for cuttings in stiff clays at that time. The cutting first failed in January 1999 as a result of a large rotational slide developing (Fig. 3). A plan showing the extent of the failure is shown in Fig. 4. The failure occurred after several months of significantly higher-than-average monthly rainfall levels, and at the end of several days of exceptionally heavy rainfall: 41 mm of rain fell on 30 December 1998.

Fig. 2 Location and plan of slip failure area near Dromore, Co. Down; OS licence no. 700714 (scale 1:20 000)
